# Manhole Inspection Summary

Manhole # S53M\_\_067MH

Insp Date: **4/3/08 11:13 AM**

**Location** Address: **3232 Dillon ODonnell**

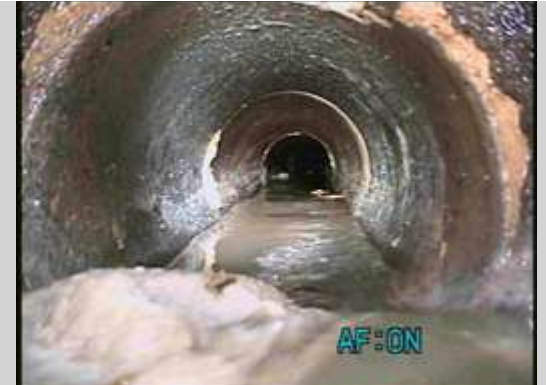
12 O'Clock Outflow

Invert Depth: 10.83 (ft.) Flow Characteristics: Fast

Deposits: ☒ None ☐ Mud ☐ Sludge ☐ Debris ☐ Grease

Infiltration: None Pipe Seal Cond: Unknown

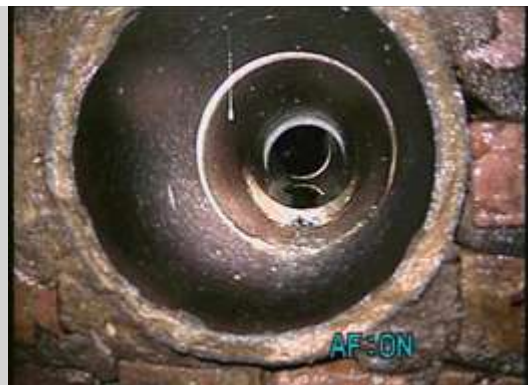
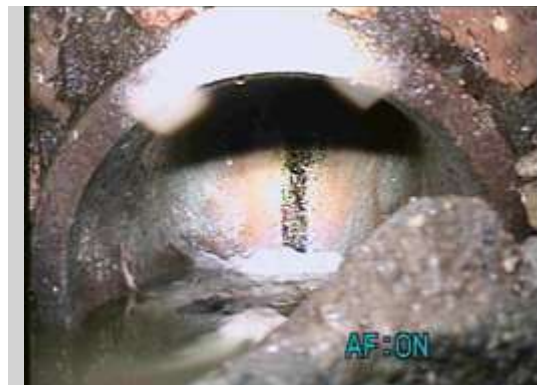
6 O'Clock Inflow

Infiltration: **None** Pipe Seal Cond: **Unknown**

Drop Condition: **Open**
